Major Structural and Civil work of Industrial Building : A Case Study

Industrial buildings are buildings which are used for industrial activities and Structural Repairs of such Industrial Buildings can be a tedious process as it requires special attention to its restoration needs and maintenance. Similarly, our project named “Tata steel-6 HI Mill Electric Room Building” at Khopoli, Khopoli - Pen Road is exposed to a dynamic environment and internal higher temperature which goes upto 45 degree Celsius and such effects can create critical and challenging conditions to execution of repair and other related work.....

The Existing Building i.e. “Tata steel-6 HI Mill Electric Room Building” is a R.C.C. framed & steel structure having Ground + 02 Upper Floors. It is used for electric control room which provide part electricity to production plant for manufacturing colour-coated sheets, high-tensile steel strappings, hardened and tempered steel strips along with CRCA steel to cater to the needs of the automobile industry.

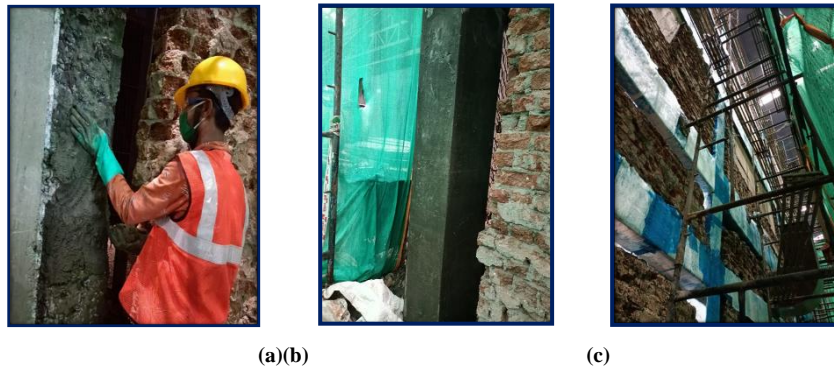
3.1 Structural Strengthening: Structural elements were found in distressed condition as Major structural cracks observed on RCC Column & Beam due to aging effect and high vibrations in the RCC building. Proper remedial actions were taken as per requirement of structural members to strengthening a R.C.C. elements with polymer treatment, micro concreting, fiber wrapping technique etc.

Fig. 1 - (a) Polymer; (b) Micro concrete; (c) Fiber Wrapping.

2.2 Polymer Modified Mortar (PMM) Internal And External R.C.C. Members: As per the observation & detail report, the defect in the RCC members are due to effect of Corrosion. The strengthening of RCC members were done from internally and also externally wherever necessary by Polymer modified mortar (PMM) technique. The detailed methodology is as mentioned below:

K. Structural up gradation and strengthening- Fiber wrapping methodology at the beam and column were done with the process as below-

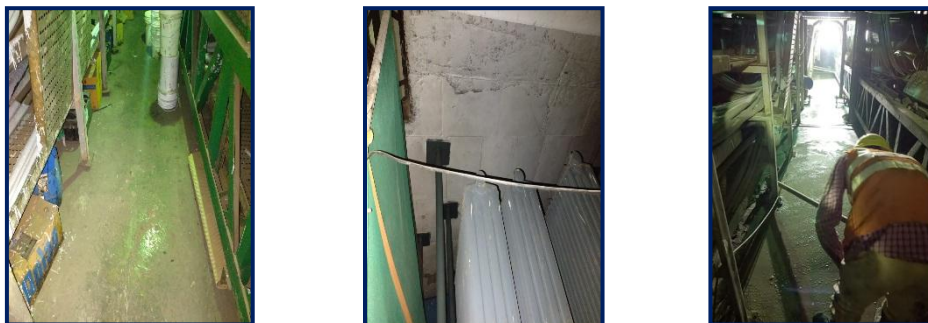
3.2 Micro Concreting at 1st Floor Slab: At First floor slab sagging at some location were observed and because of Sagging some cracks developed on it. To rectify the distress of sagging slab high strength and free flow non-shrink micro concrete was applied with making sure of necessary arrangements such as watertight shuttering and scaffolding etc. After micro concreting treatment said slab found in satisfactory in condition.

Fig. 2–Slab Micro Concreting

J. Encasing Micro concrete- The areas where core concrete was found damaged and also the sagged slab at 01st floor level, high strength, free flow non-shrink micro concrete was applied after making necessary arrangements of watertight shuttering and scaffolding when the bonding coat is tacky.
