Causes and Learning Outcomes from a Uniquely Sudden Collapse of a under Construction Road Tunnel in Himalayan Geology: A Case Study

Present study deals with the various causes and learning outcomes from a uniquely sudden collapse of a under construction road tunnel in the Himalayan geology. On 12 November 2023, a section of the Silkyara Bend–Barkot tunnel, planned to connect National Highway 134 in the Uttarkashi district of Uttarakhand, India, caved in while under construction. The collapse occurred at around 05:30 IST. Based on the available technical data during the geotechnical investigation before execution ,construction periods and also the data taken after the collapse of the above said tunnel a detail investigation has been done to find out the various reasons behind the collapse. The important observations which was found in the geological investigation report (GIR) during preconstruction were overlooked and not addressed during the design phase of the tunnel. This paper also deals with the preventive measure to avoid such incident in sensitive Himalayan region in future.

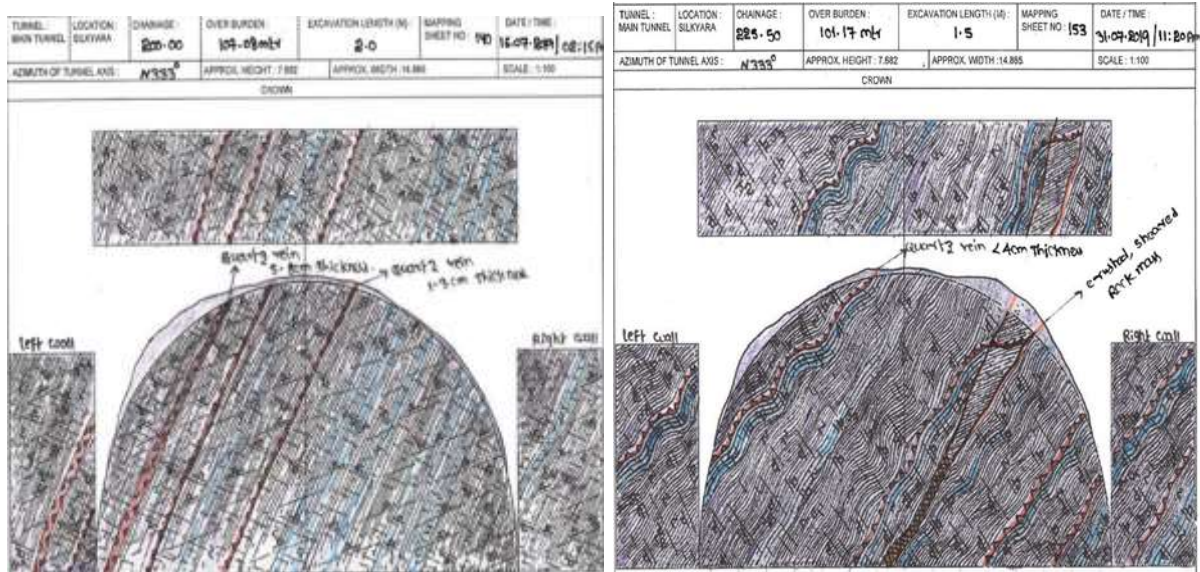
A two-dimensional (2D) analytical model for estimating the face stability of a Phyllite rock tunnel was done in the presence of rock mass stratification. The rock layer thickness on tunnel face stability, tunnel diameter, the arrangement sequence of weak and strong rock layers, and the variation in rock layer parameters at different positions was carried out. The results indicate that the thickness of the rock layer, tunnel diameter, and arrangement sequence of weak and strong rock layers significantly affect the tunnel face stability. Variations in the parameters of the lower layer of the tunnel face have a greater effect on tunnel stability than those of the upper layer. Different RMR and support classes used in various hainages are described in the table-2. Engineering Geological Mapping of tunnel face 200 and 225 is shown in fig-1.

Fig.1 Engineering Geological Mapping of tunnel face 200 and 225

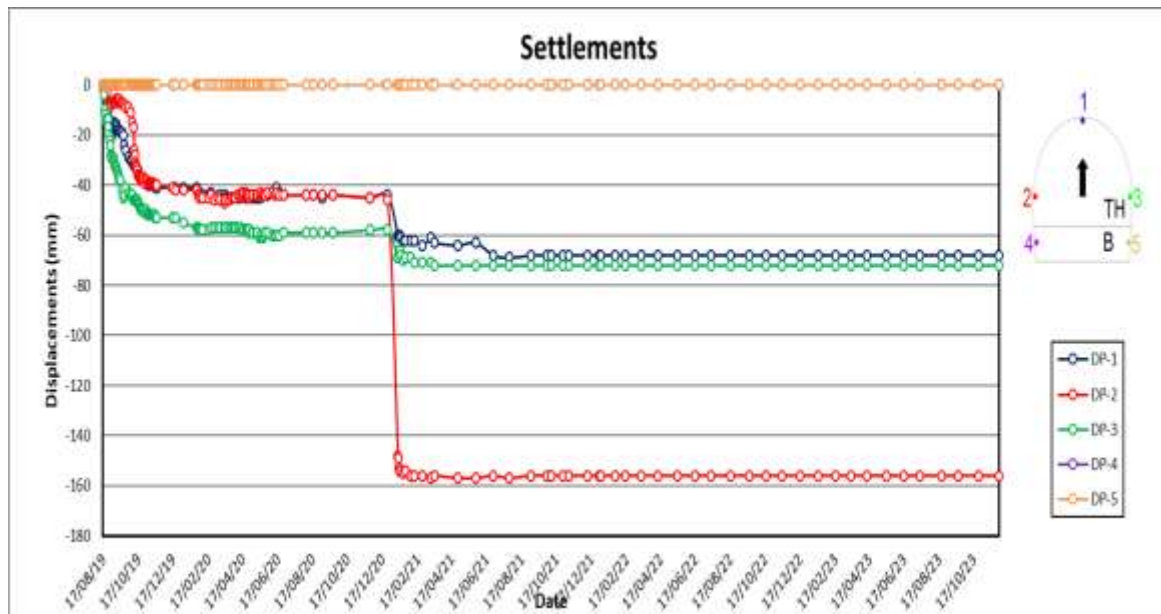
During study of finding the reasons of collapse it was found that only 3D monitoring datas were available that did not give the complete scenarios of ground behavior. Thus, the complete geotechnical interpretation could not be carried out to tackle or counter the appearing of sudden surprises which are expected to appear in such sensitive Himalayan zone.

Fig.2 3D target settlement graph

4. An additional tunnel monitoring equipment should be installed to have better understanding of behavior of rocks.
5. Proper record of Daily Review Meeting (DRM) shall be developed by the competent technical personals and the recommendations/observation shall be documented.
