Evaluation of User Comfort on The Pedestrian Path of Nicolau Lobato Street, Comoro, Dili

Maria Votancia Agostinha Da Silva Babo^a, I Made Sukewijaya^b

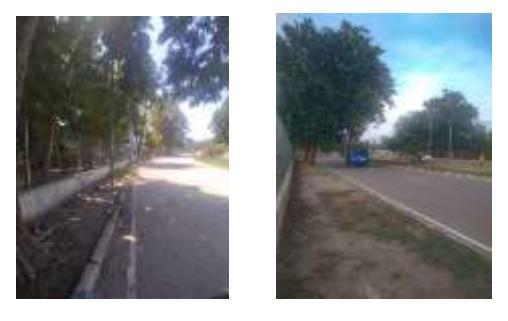
The sidewalk in Segment I has a narrow width on the eastern side.

Eastern Section (2) Western Section
Figure 2. Comfort Conditions of Nicolau Pedestrian Pathway

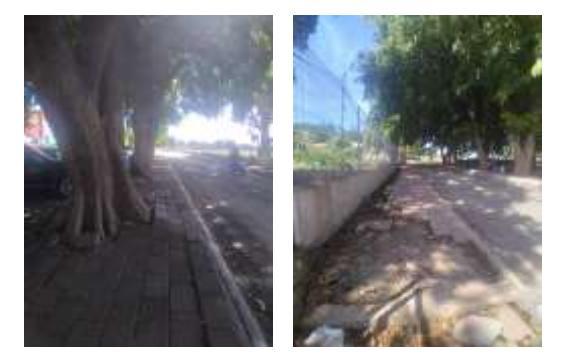
The sidewalk in Segment II is damaged and narrow. The surface condition of the sidewalk in Segment II is uncomfortable for pedestrians due to damage. Some trees obstruct the pathway, and there are also potholes and uneven surfaces in certain spots on the sidewalk.

Figure 3. Comfort Conditions of Pedestrian Pathway in Segment II

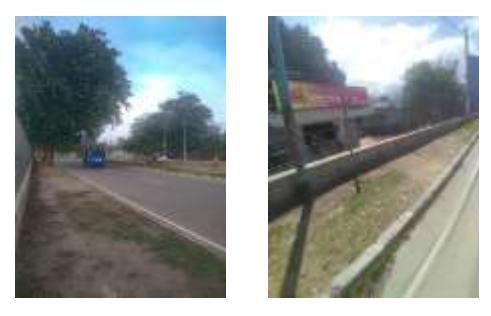
Based on the analysis results from Table 2, compliance is only found in Segment I on the western side, while Segment I on the eastern side does not meet the criteria. Similarly, Segment II does not meet the criteria. The existing width conditions of the pedestrian pathway on Nicolau Lobato Street are illustrated in the image below.

Figure 4. Existing Conditions of Pedestrian Pathway Width and Surface Shape on Nicolau Lobato Street

Repairing the surface conditions of the pedestrian path in segments I and II on the eastern side with a smooth, stable, and robust surface to prevent accidents. Additionally, there is a need for a wider pedestrian path to ensure comfortable walking for users.

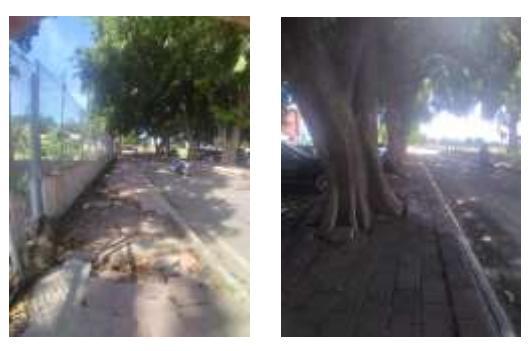
Based on Table 1, the pedestrian pathway in Segment I has uneven width. Segment I has a pedestrian pathway with a fairly busy pedestrian activity, as does Segment II. The pedestrian pathway in Segment II also has a narrow width. Segment II has a pedestrian pathway with quite busy pedestrian activity, and there are also shops, restaurants, and vendors in the vicinity. Table 3 presents the results of the analysis of the existing width of the pedestrian pathway on Nicolau Lobato Street.

Figure 5. Existing Conditions of Pedestrian Pathway Width and Surface Shape on Nicolau Lobato Street, Segment II

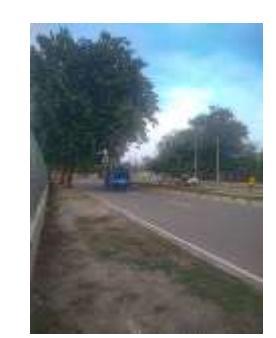
Based on observations on the pedestrian pathway on Nicolau Lobato Street, the surface of Segment I on the western and eastern sides does not have paving. There is no paving on both the eastern and western sides of the pedestrian pathway on Nicolau Lobato Street. In Segment II, the observation results indicate uneven surfaces and damages due to various activities, as well as some trees damaging the pathway surface.

Figure 6. Surface Condition of the Pedestrian Pathway on Nicolau Lobato Street in Segment I
