Safety Audit (RSA) on NH-56- Khamera – Padoli

Aarya Pal¹, Rakesh Verma²

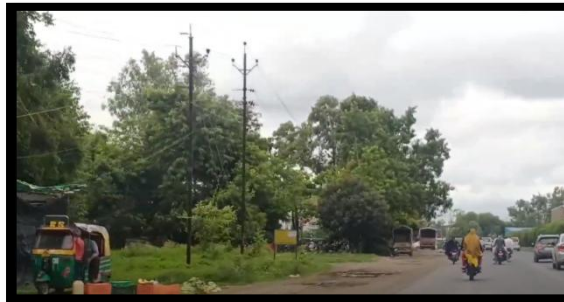
Figure 4.3(a): Speed and Delay Study

In the east-west direction, the average journey speed in the survey stretch was 50.6 kmph and the average delay for the entire study length was

2.26 minutes, whereas in the west-east direction, the average journey speed in the study stretch was 51.25 kmph and the average delay for the entire study stretch was about 2.0 minutes. Parking on the roadway has caused traffic congestion at the Padoli Gordhan, Jetpura, SenawasaandChitaurgarh S.O. Post Office

The study showed that from east-west direction, the average journey speed in the survey stretch was 50.6 kmph and the average delay for the entire study length was 2.26 minutes, whereas in the west-east direction, the average journey speed in the study stretch was 51.25 kmph and the average delay for the entire study stretch was about 2.0 minutes. Parking on the roadway has caused traffic congestion at the Padoli Gordhan, Jetpura, Senawasa and Chitaurgarh S.O. Post Office respectively.

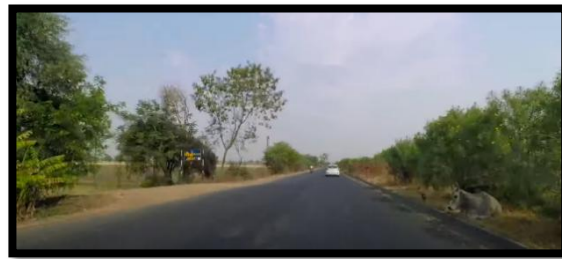
Figure 5.1: Problem Identification at chainage CH 2.8 (Ghatol)

Problems identified at the selected stretch throughout were as follows:-

- a.) Absence of Animal Barriers throughout the selected road stretch.
- b.) No crash barriers throughout the selected road stretch.
- c.) Unrestricted T-section crossing with no signage
- d.) Movement of cattle on road.

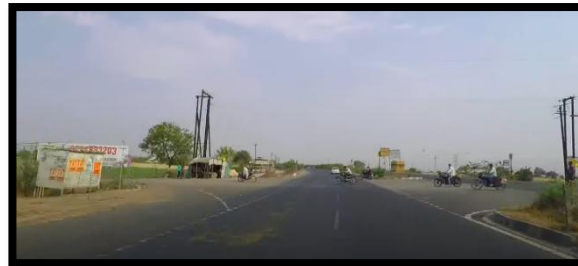
Figure 5.2: Problem Identification at CH 4.3 (Padoli Gordhan to Chitaurgarh)

5.1.2 Absence of Speed Breaker and Signal facilities at CH 4.3 (Padoli Gordhantowards Chitaurgarh)

Problems identified during this section of stretch were as follows:

Recommendations:

- a.) A speed hump shall be provided in accordance with IRC 99-1988 recommendations, with a width of 3.7 metres, a height of 0.1 metres, and a radius of 17 metres for a preferred advisory crossing speed of 25 kilometres per hour. It must be in white paint markings to make it more visible at night.

- d.) Guard barriers should be placed right 0.5 m from the kerb to allow enough room for passing cars and to safeguard traffic users, as it becomes a safety hazard.

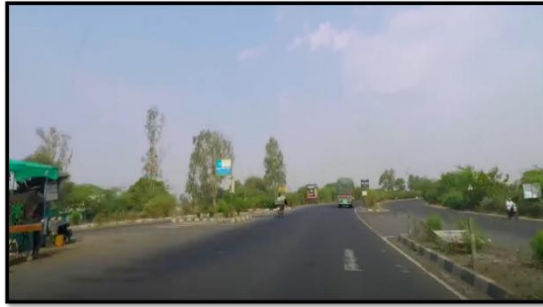
Figure 5.3(a): Unsignalized intersection at CH 5.4 (Padoli Gordhan)

- a.) Unsignalized Intersection without proper traffic sign.
- b.) Unsignalized Y-Intersection with improper marking of medians.
- c.) Visual obstruction by a hand cart alongside road of the Y-Intersection with traffic separators.
- d.) Decrement in road width by illegal hoarding board installation.
- e.) No visible traffic marking throughout road.
- f.) Parking in the restricted parking area.

Recommendations:

- a.) Marking of road shall be prepared in accordance with IRC: 35-1997 rules;
- b.) All Y-junction and T-junction must have give-way markings;
- c.) At the shoulders, dust must be eliminated;
- d.) Because road markings exhibit wear and tear in some areas, they must be kept in good shape and their visibility at night must be examined on a regular basis.
- e.) Old marks must be appropriately erased to prevent cars from misinterpreting the message.
- f.) At every turn, bus stop, and school, there must be road information markings;
- g.) To ensure nighttime safety, retro-reflective road markings must be installed.

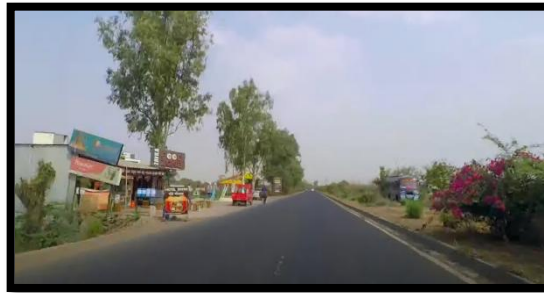
Figure 5.3(b): Reduction in Road width by Roadside Dhaba at CH 5.7 (Padoli Gordhan)
