## **PRELIMINARY ANALYSIS OF MICROBIAL CONTAMINATION AND WATER QUALITY PARAMETERS OF MAMAM RIVER IN THIRUVANANTHAPURAM DISTRICT, KERALA**

*Divya.S. Rajan<sup>1\*</sup>, Devika Anil<sup>2</sup>, Anjana.A.G<sup>3</sup>, Anand.P.Nair<sup>4</sup>, Abhina.P<sup>5</sup>, Akhila.A<sup>6</sup>, Navaneeth.S<sup>7</sup>*

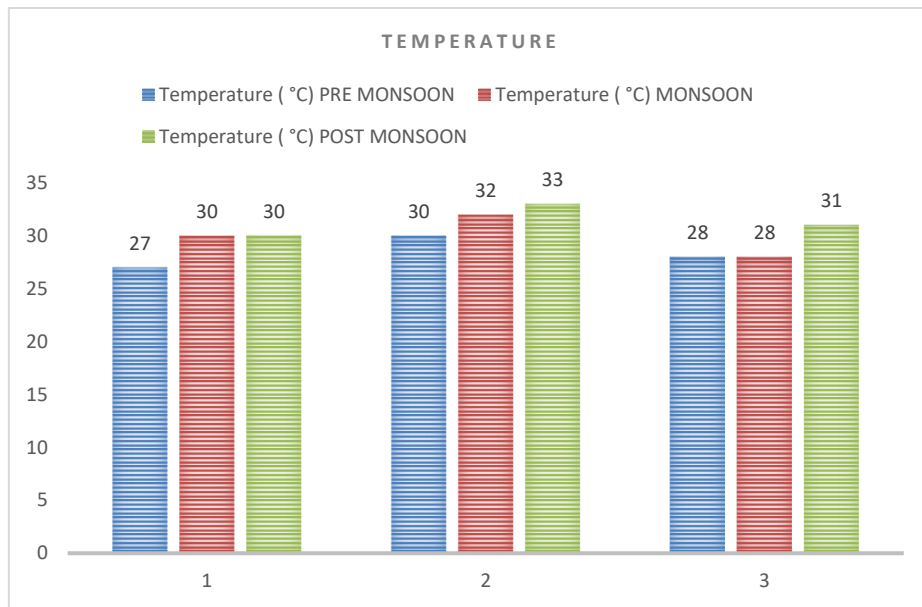
Fig.2 Temperature fluctuations

A minimum range of 27°C and a maximum range of 33°C temperature was exhibited among stations. A high range of temperature in the pre-monsoon season was observed in station 2(30°C) and a low range of temperature was observed in station 1(27°C). In the monsoon period, the temperature of the water sample in the post-monsoon period ranges from 30°C to 31°C. Table (1), fig(2). The mean  $\pm$  standard deviation ranges from 28.33 $\pm$ 1.52 to 31.33 $\pm$ 3.05.

The temperature is playing a pivotal role in altering the physical, chemical and biological properties of water. The maximum temperature was recorded in post monsoon season (33 °C) and minimum at pre monsoon season (27°C). Considering the three stations, high temperature was observed in station 2 (33°C) during Post monsoon season. The variation in temperature may be due to the change in climate and the time of analysis. The water quantity may depend on the changes in temperature. The variation in temperature may be due to the change in climate and the time of analysis. The water quality may depend on the changes in temperature. [9].

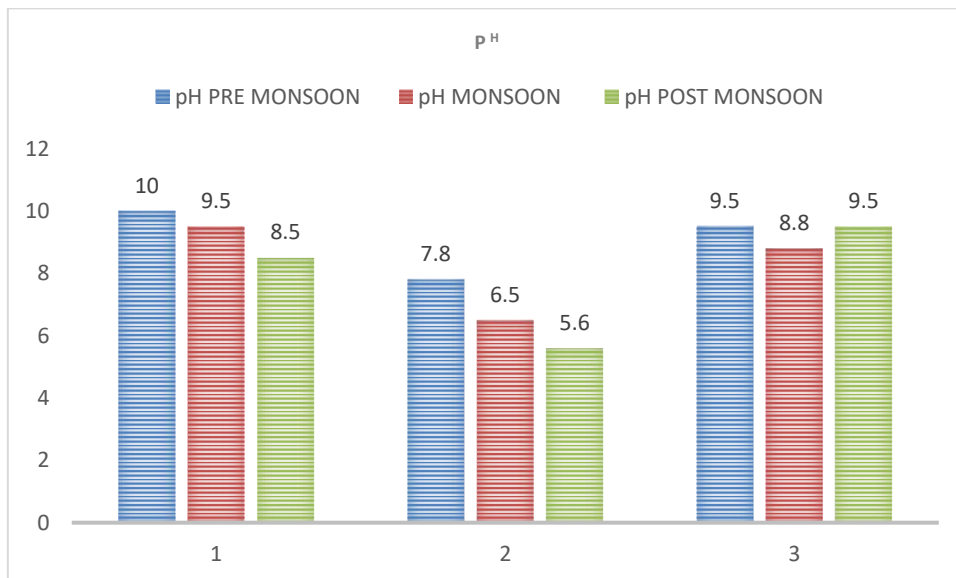
Fig.3 pH variations

pH ranged from 5.6 - 10 in the pre-monsoon season. station 1(10) and lower pH level in Station 2 exhibited a higher level of acidic pH (5.6). In post-monsoon, pH of water sample ranged from 5.6 to 9.5. pH ranges 6.5 to 9.5 in monsoon period. fig(3). The mean  $\pm$  standard deviation ranges from 9.1 $\pm$ 1.15 to 8.26 $\pm$ 1.56.

All aquatic organisms have an optimum pH known as minimum pH for their sustenance. Any alteration in pH can change the acidity or basicity of water. In station 1, during pre-monsoon The maximum pH was reported (10). pH is probably by far the most important parameter regulating the behaviour of other water quality parameters as well as the presence of metals in the aquatic environments [2].

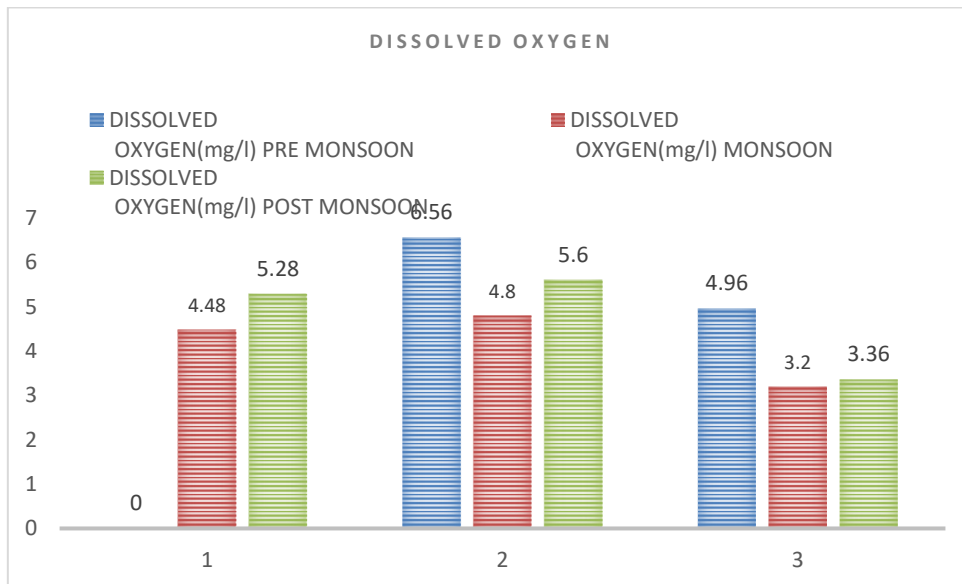
**Fig.5 Dissolved oxygen fluctuations**

Dissolved Oxygen Maximum range of Dissolved oxygen was observed in station 2, (6.56mg/l) and minimum range was observed in station 1. Maximum range of Dissolved oxygen was observed in station1,(4.48mg/l) and minimum range was observed in station3( 3.2mg/l) .In the post monsoon season maximum range was shown in station2,(5.6mg/l) and minimum range was observed in station3,(3.36mg/l) fig(5). The mean  $\pm$ standard deviation ranges from  $4\pm 0.84$  to  $5.76 \pm 1.13$ .
