Understanding and Mitigating the Causes of Accelerated Building Deterioration in the Coastal Communities of the Niger Delta

Anthony Dornubari Enwin

Department of Architecture, Faculty of Environmental Sciences, Rivers State University, Port Harcourt, Nigeria.

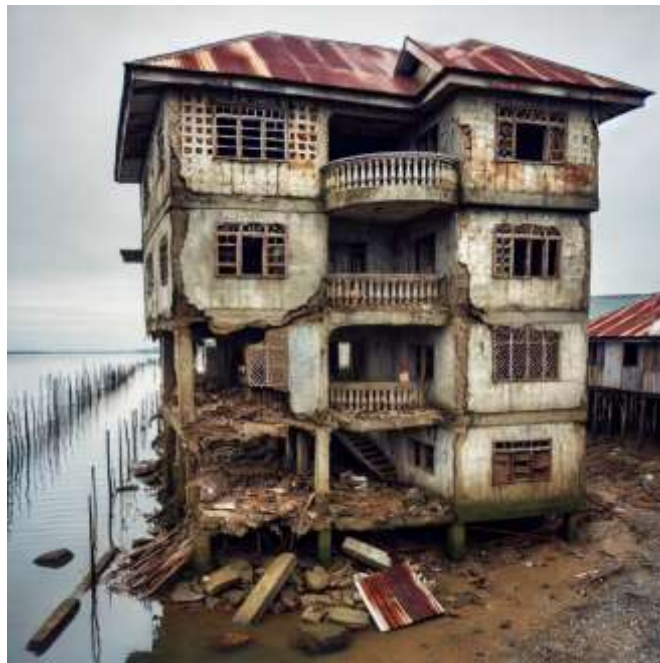
Plate 1: Exterior View of a Deteriorating Building in Bonny Island, Rivers State

Location: Bonny Island, Rivers State, Nigeria

Building Type: Residential duplex

Building Materials: Reinforced concrete, sandcrete blocks, corrugated roofing sheets

Over the past decade, the building has exhibited various forms of deterioration, including:

Foundation Erosion: Progressive weakening due to coastal erosion and rising sea levels.

Concrete Spalling: Exposure to salt-laden moisture leading to corrosion of reinforcement bars.

Roof Corrosion: Rusting and weakening of the metal roofing sheets due to high humidity and salt spray.

Mold and Mildew Growth: Persistent moisture retention in walls, causing fungal infestations.

Structural Cracks: Visible cracks in walls and floors due to ground subsidence and material degradation.

Several environmental and human-related factors contribute to the deterioration of the building:

Coastal Erosion: Wave action and tidal movements have gradually eroded the soil supporting the foundation.

Saltwater Intrusion: High salinity in the groundwater accelerates the corrosion of steel reinforcements.

Heavy Rainfall & Flooding: Frequent storms and seasonal flooding increase water infiltration into the building.

Poor Construction Practices: Inadequate concrete mix ratios and lack of proper coastal reinforcement during construction.

Neglect & Maintenance Issues: Limited maintenance interventions exacerbate structural vulnerabilities.

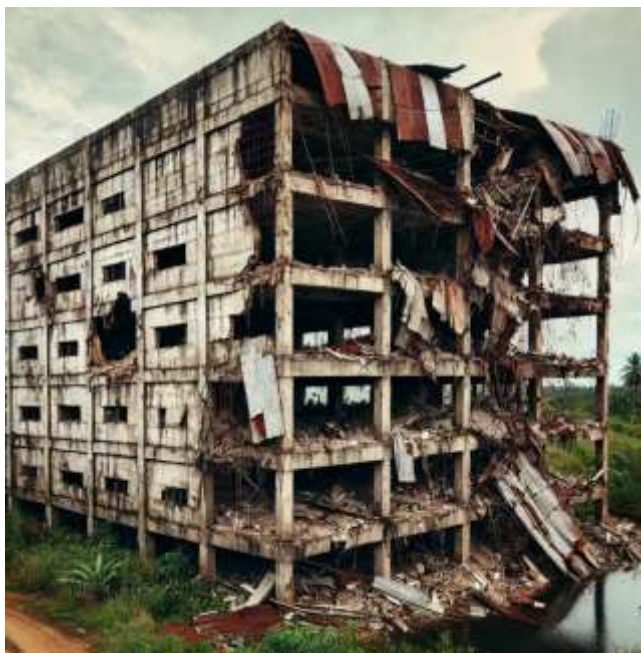
Plate 1: Coastal Building Deterioration in Forcados, Niger Delta, Nigeria

Location: Forcados, Delta State, Nigeria

Building Type: Abandoned commercial structure

Building Materials: Reinforced concrete, clay bricks, galvanized roofing sheets

Current Status: Partially collapsed due to severe deterioration

The building has exhibited multiple signs of deterioration, including:

Severe Foundation Instability: The foundation has suffered from extensive soil erosion, leading to partial collapse.

Cracks and Structural Weakness: Large fissures run through walls and columns, weakening the overall structure.

Corrosion of Reinforcements: High salinity has accelerated the corrosion of embedded steel rods, leading to concrete spalling.

Roof Decay: Galvanized roofing sheets are rusted, with some sections completely missing due to storm damage.

Overgrown Vegetation: Trees and shrubs have grown inside and around the structure, further compromising stability.

Coastal Erosion & Land Subsidence: The continuous loss of land due to wave action has destabilized the foundation.

Saltwater Exposure: Prolonged exposure to salt-laden air and water has accelerated material degradation.

Lack of Maintenance: The building has been neglected for years, allowing minor damages to escalate.

Heavy Rainfall & Flooding: Seasonal floods have continuously weakened the lower walls and flooring.
