## Hazard Risk Rapid Assessments of Evacuation Centers at the Municipality of BOAC in the Central Marinduque Fault Line's Vicinity

### ABSTRACT –

**Keywords:** *Rapid Visual Screening, Seismic Vulnerability Map, Evacuation Centers, Quantum Geographic Information System, Central Marinduque Fault Line*

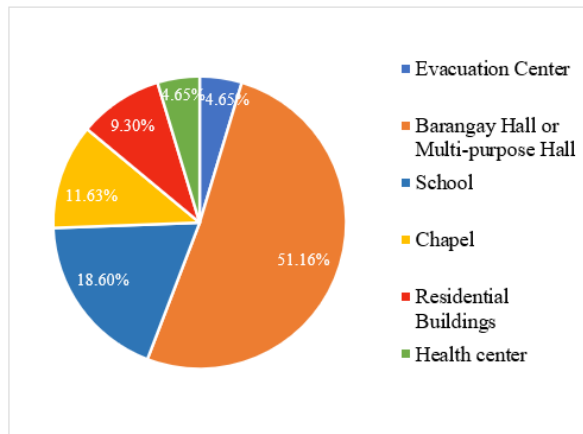
Figure 1: Distribution of Designated Evacuation Centers

Barangay halls or multi-purpose halls are the most commonly used facilities as evacuation centers in twenty-four (24) barangays since those barangays lack evacuation centers, and the barangay hall or multi-purpose hall is the most available and convenient for people to seek shelter once disaster strikes or during emergencies.

Other facilities including School Buildings, Chapels, Residential buildings, and Health Centers are used as designated evacuation centers.

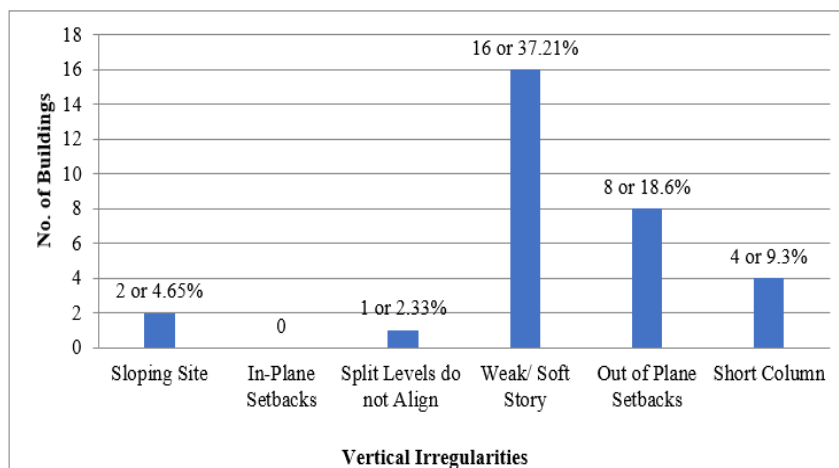
When it comes to irregularities, specifically moderate vertical irregularities, results suggest that sloping sites and split levels are present in some facilities. On the other hand, the type of severe vertical irregularities present in some facilities includes weak or soft stories, out-of-plane setbacks, and short columns. In terms of plan irregularity, torsion is the most common, followed by beams that do not align with columns and non-parallel systems.

Figure 2: Distribution of Designated Evacuation Centers with Vertical Irregularities

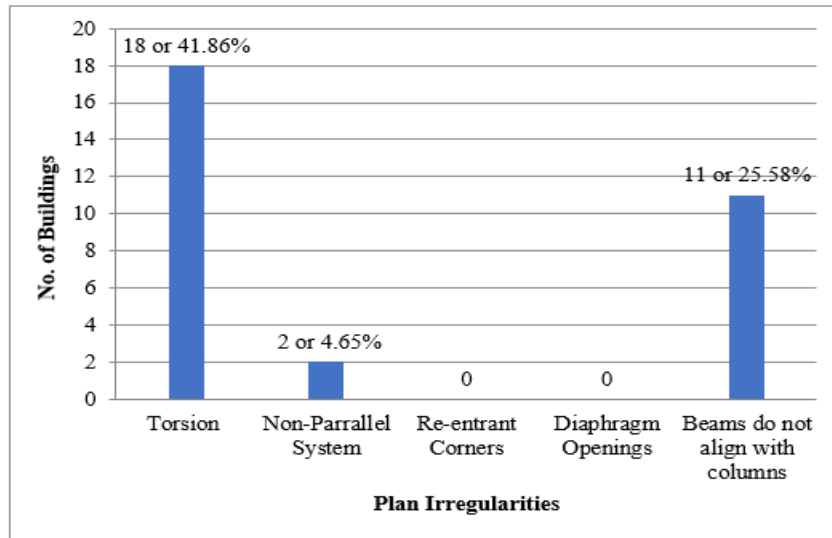
Figure 3: Distribution of Designated Evacuation Centers with Plan Irregularities

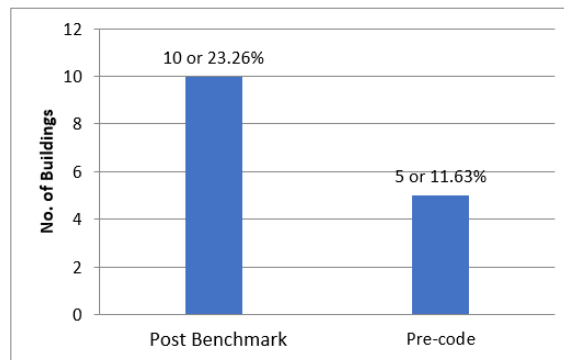
Figure 4: Distribution of Designated Evacuation Centers in which Pre-code and Post Benchmark Year Applies

In addition, Pre-Code was applied to five (5) buildings since these buildings were built before the adoption of codes, or before the year 1972. A post-benchmark was applied to ten (10) buildings since they were built after 2015 or after the adoption of substantially improved codes.

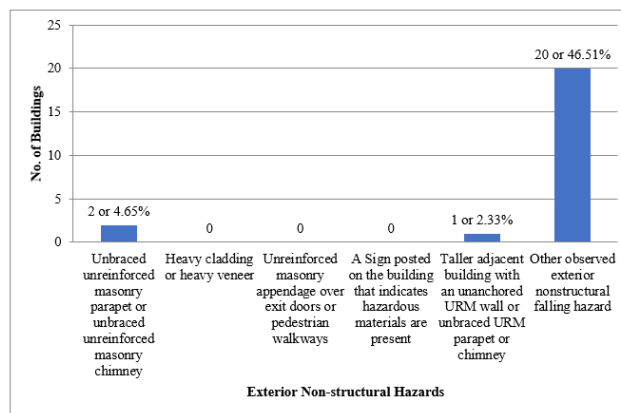
Figure 5: Distribution of Designated Evacuation Centers with Exterior Non-structural Hazard

With regards to the non-structural hazards, the most prevalent is the observed presence of trees near the location of the structures, as these would constitute exterior falling hazards in an earthquake. There is also an unbraced unreinforced masonry parapet and a taller adjacent building with an unanchored URM wall or unbraced URM parapet. On the other hand, several designated evacuation centers were observed to have glass walls and windows, unsupported cabinets, TVs, bookshelves, desktop, and countertop equipment, and deteriorating wood trusses and ceilings in close proximity to evacuees that would still put the occupants at risk. Such hazards are existing non-structural hazards that require mitigation, but a detailed evaluation is not necessary.

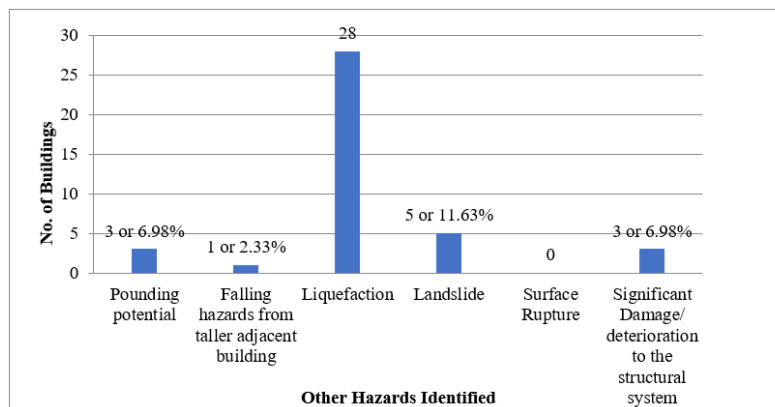
Figure 7: Distribution of Designated Evacuation Centers with Other Hazards Identified

Some facilities have been found to be at risk in terms of other identified hazards, which include pounding potential and falling hazards from taller adjacent buildings. In terms of geologic hazards, landslides were found at the building sites of five (5) evacuation centers. In addition, there are three (3) of the designated evacuation centers that have significant damage or deterioration to structural systems.
