Misplacement of Central Venous Catheter into Inferior Vena Cava

Dr Tarun Yadav^{1}, Dr Mayuri Golhar², Dr Suresh Singhal³*

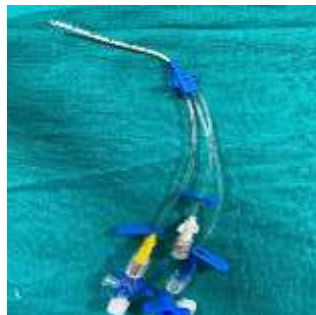
Figure 1 . Proximal part of torn central venous catheter

Our patient had history of polytrauma from roadside accident. He was in hemorrhagic shock so right sided subclavian vein catheter placed for resuscitation. It got blocked and blood could not be aspirated from any port so surgical team decided to remove it. During removal it stretched and broke down while a part remained in patient's vasculature. Chest X-ray didn't show the remaining part. 2D Echocardiography revealed tip of torn central line inside inferior vena cava which was confirmed by CT scan. Interventional removal could not be planned as patient wasn't able to afford cost.

Ideal management would have been immediate fluoroscopic guided interventional removal of fractured end with a gooseneck snare but unfortunately patient was not able to afford the expenses. But more than that prevention of such complication was possible by avoiding excessive force, may be taking the central venous catheter out over guide wire using seldinger technique could have been a better option. So it is a lesson to be learned not to forcefully attempt the removal of central venous catheter in case of any resistance is experienced while pulling it.

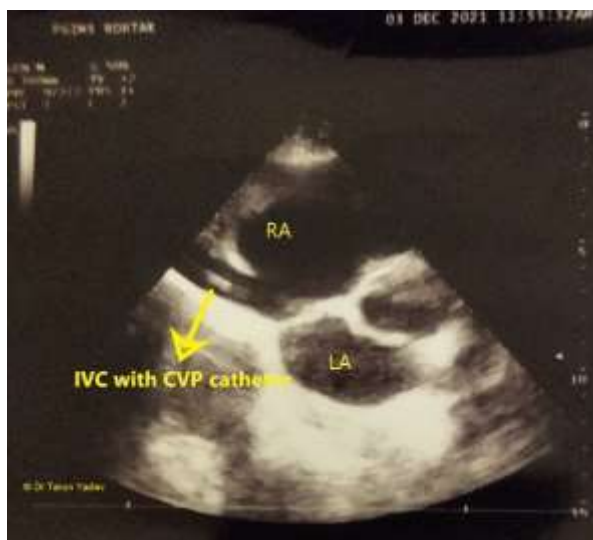
Figure 2 . Distal part of torn Central venous catheter seen in Inferior Vena Cava in subcostal view.

Use of ultrasound has not only decreased the complications related to catheter placement but also diagnosis of its complications like pneumothorax, vascular injury, misplacement¹ etc. Great care should be undertaken while removal of central venous catheter as it may break and distal part can embolize in major vessel. In our patient the broken part got struck in inferior vena cava leading to hemodynamic instability and arrest.
