Enhancing Road Safety Along Critical Stretches of NH-57: A Case Study in Odisha

Manaswini Sahoo¹, Dr. Jyoti Prakash Giri²

¹PG Student, Centurion University of technology and Management, Bhubaneswar, Odisha, India, 752050. Email: 220303230005@cutm.ac.in

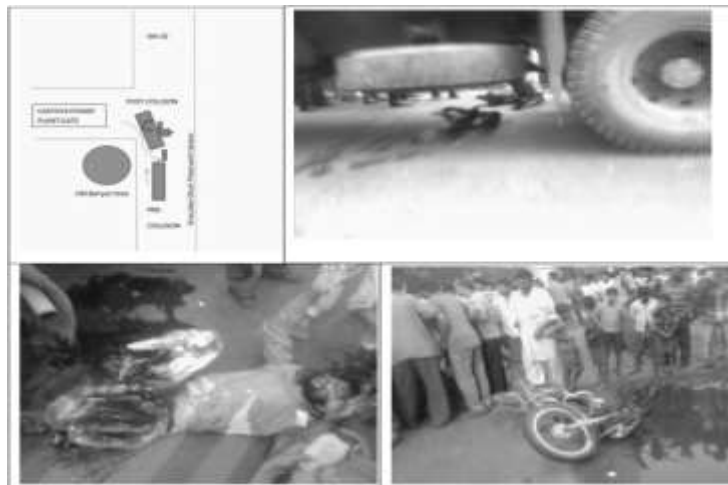
Accident no-1

Accident type: Head-on collision

Location: Khurda-Baghamari area near Pubusahi

Date and Time: May 10, 2019; 10.30AM

It's tragic to hear about the hit-and-run incident near Pubusahi Chowk in Khurda district. The victim, while returning home on his motorcycle, was struck by a speeding vehicle, which callously fled the scene, resulting in the loss of life. Emergency services arrived after a significant delay, and despite efforts, the victim succumbed to their injuries at the scene. Law enforcement authorities swiftly responded, recovering the victim's body for post-mortem examination and initiating investigations into the incident. Preliminary findings suggest that the accident occurred due to the reckless speeding of the vehicle, compounded by the absence of cautionary signboards warning about upcoming rumble strips. Such incidents underscore the critical need for enhanced road safety measures and stricter enforcement of traffic regulations. Adequate signage and road markings play a crucial role in alerting drivers to potential hazards, thereby reducing the risk of accidents. Additionally, swift emergency response and timely medical assistance are imperative to mitigate the severity of injuries and save lives in such tragic circumstances.

As investigations progress, It is crucial to establish accountability for those at fault and enact measures to prevent the recurrence of similar incidents in the future. Ultimately, the goal is to create safer roadways for everyone.

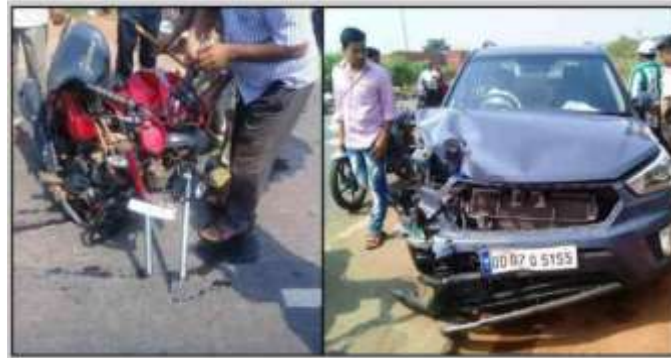
Accident No-2

Accident type: 1 Critical, 4 person severely Injured

Location: Baghamari-Begunia area near Begunia

Date and Time: Feb 6, 2018; 07.45AM

This morning, a series of collisions occurred on the Baghamari-Begunia road, resulting in injuries to five individuals. The chain of events began when a pick-up van transporting bananas collided with a motorcycle and subsequently overturned. Subsequently, two auto-rickshaws and a Tata AC vehicle collided with the overturned van. As a result, five people sustained injuries, with one individual in critical condition. Emergency services swiftly responded to the scene, transporting the injured individuals to Khurda Hospital for medical treatment. However, the accident has led to disruptions in traffic flow along the national highway in the Baghamari-Begunia road section.

Local law enforcement, represented by Baghamari police, has initiated an investigation into the incident to ascertain the sequence of events and determine factors contributing to the collision. Their efforts aim to establish accountability and prevent similar incidents in the future, ensuring the safety of road users in the area.
