Assessing the Impact of Road Safety Measures in Odisha's Accident Prevention

4. SAFETY OBSERVATION AND RECOMMENDATION

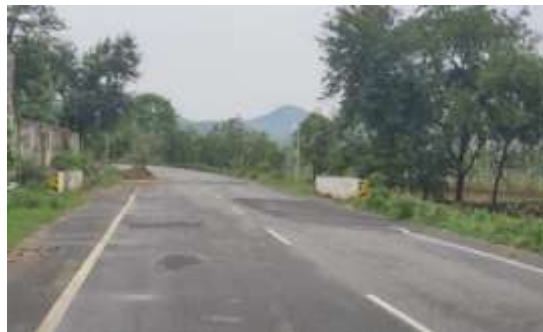
Fig – I represent the absence signboard of OHM

Observation:- Lacking of object hazard markers at bridge/CD/trees are potential safety hazard not only during night hours but also in day time which is shown in Fig - I

Recommendation:- Object hazard markers shall be installed at every parapet of CD/bridge on faces of both traffic direction with conforming IRC-67:2012-15.64.

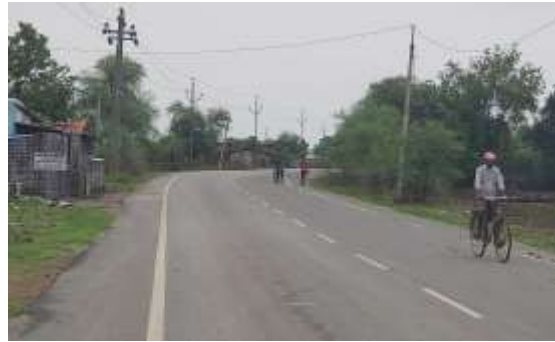
Fig -II shows the absence of curve signboard.

Observation:- Lack of informatory sign (speed limit, Left/Right turn), Chevron sign board & solid center line are required (Fig – II)

Recommendation:- All curve shall have warning and informatory sign board with conforming IRC: 67-2022 and Curve having less than 450m radii are no overtaking zone shall be marked solid line at center as per IRC: 35:2015.

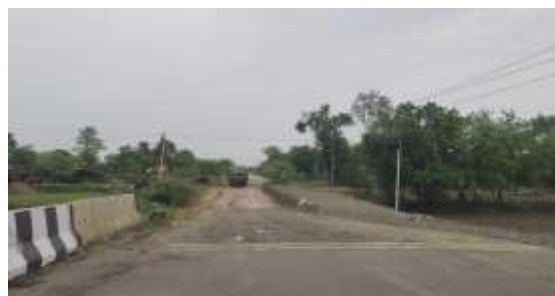
Fig – III Absence of safety measures in construction zone.

Observation:- Major/Minor bridge work is continued without proper construction safety measures.(Fig – III)

Recommendation:- Diversion sign. Safety ribbons, advance cautionary sign and maintenance of the diversion road has to provide till end of the construction.

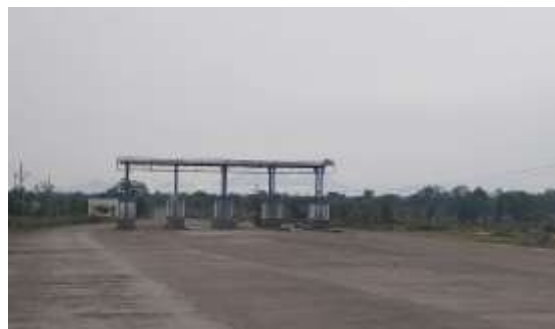
Fig-IV Lack of signboards and marking in approach of Toll Gate

Observation:- Impact Attenuators, Exterior lighting and Interior lighting and road marking is not provided.(Fig-IV)

Recommendation:- Interior and Exterior lighting at Toll Plaza area has to installed as per Clause No. 10.11 of the IRC SP 73-2007 Road sign and Road marking shall be given as per IRC 67-2012 and IRC: SP:73-2007.

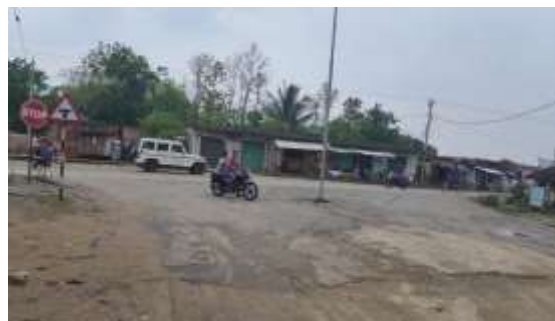
Fig – V represent the junction.

Observation:- At junction transverse bar marking, Pedestrian marking rumble sign, speed limit sign, intersection sign boards on project road and major road ahead sign, stop sign and rumble sign boards are not provided leads to confusion in the mind of user and potential for head on collision.(Fig-V)

Recommendation:- All junction shall have transverse bar marking, rumble sign, speed limit sign, intersection sign on project road and major road ahead sign, stop sign and rumble sign at approach road for providing utmost safety to the users.Existing pole shall be protected by providing Concrete pedestal and impact attenuators sign.
